SUPPORTING THE GEORGIA WORLD CONGRESS CENTER

February 14, 2014

**Subject: Quarters-38/39 Landfill Maintenance and Inspection Report
 Northside Drive Landfill Site, Atlanta, Georgia**

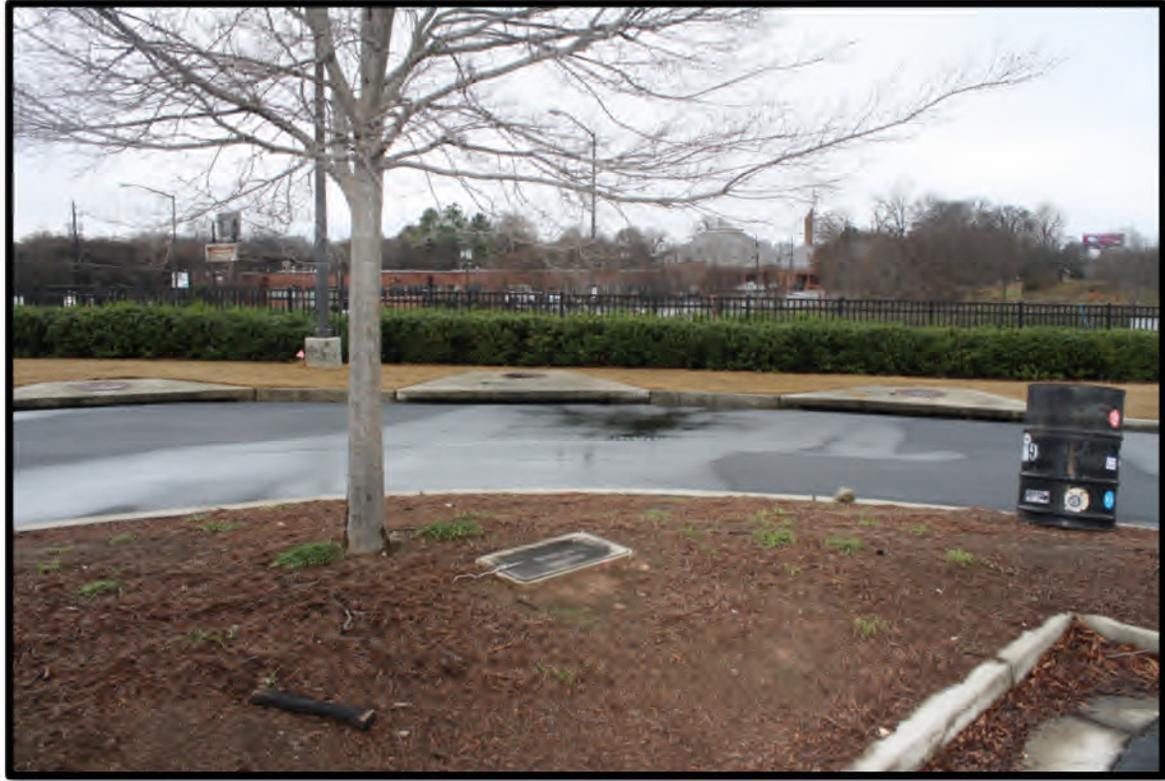
**OFFICIAL PHOTOGRAPH NO. 24
TETRA TECH**

Subject: Stormwater drains located at the northwest parking lot perimeter.

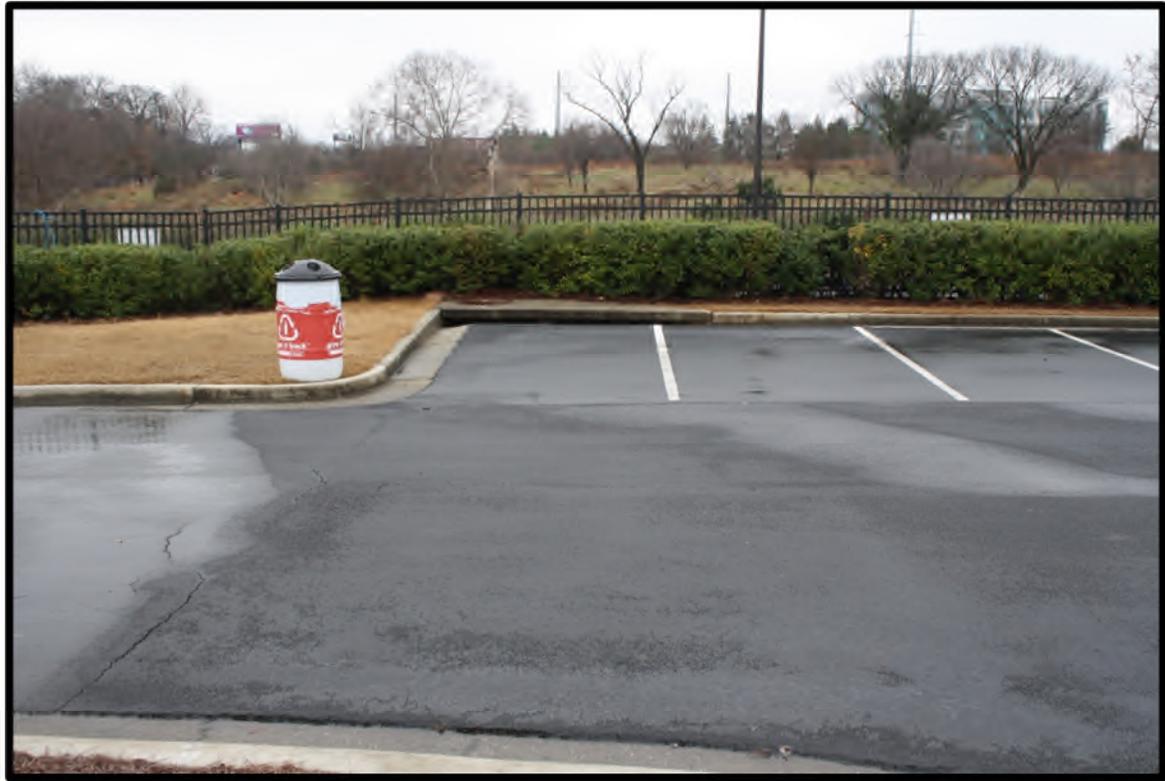
OFFICIAL PHOTOGRAPH NO. 25
TETRA TECH

Subject: Stormwater drain located at the northwest parking lot perimeter.

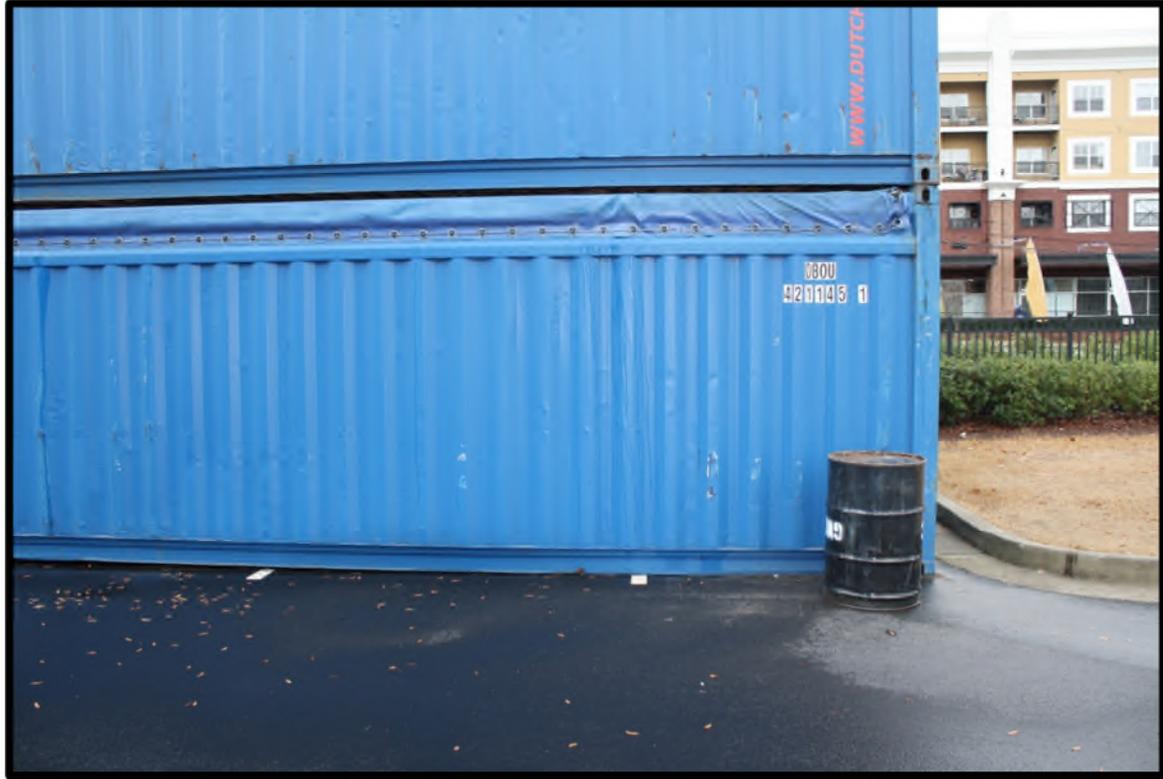
**OFFICIAL PHOTOGRAPH NO. 26
TETRA TECH**

Subject: Location of stormwater drain on the west side of the parking lot perimeter. A cargo container is being stored in front of the drain.

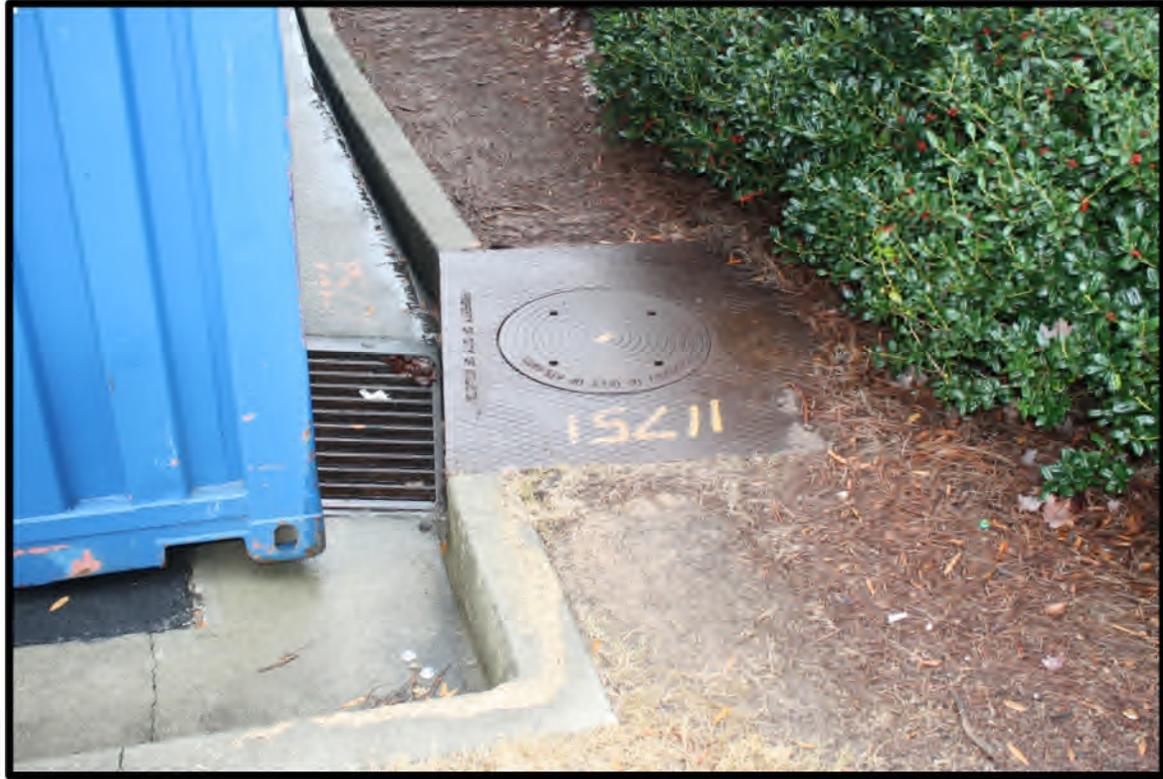
OFFICIAL PHOTOGRAPH NO. 26A
TETRA TECH

Subject: Close-up view of the stormwater drain located behind the cargo container stored along the west side of the parking lot perimeter.

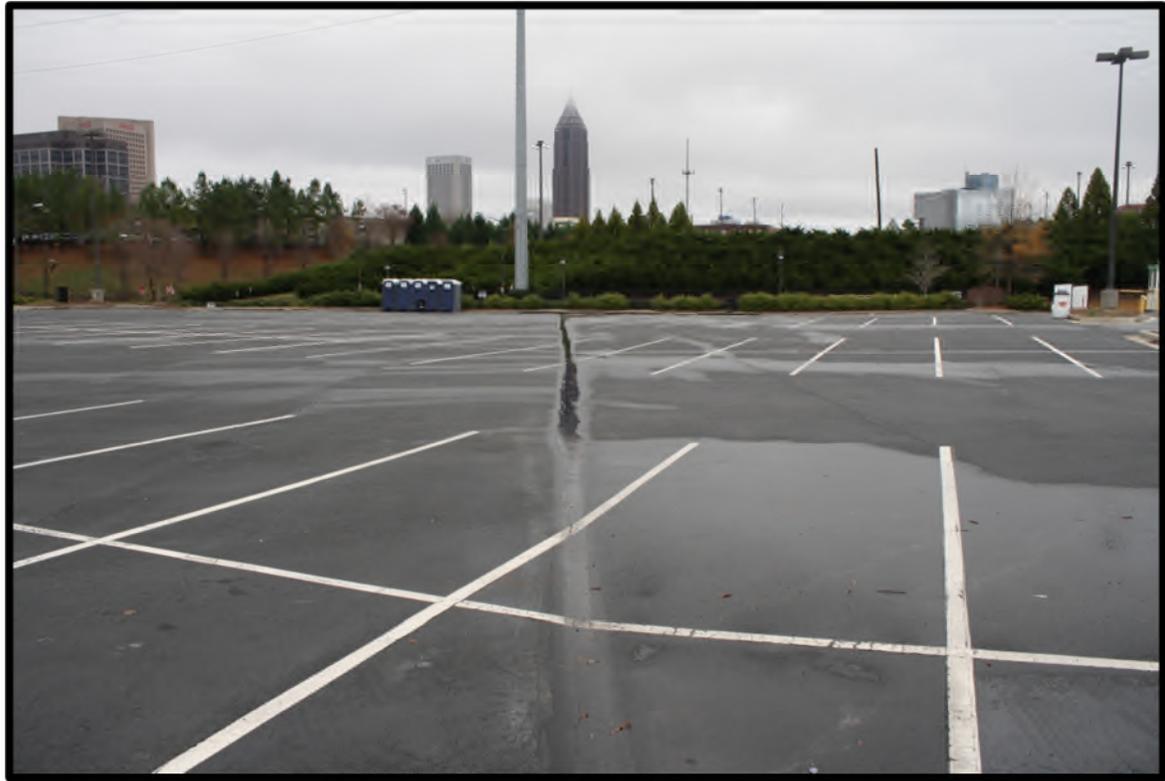
OFFICIAL PHOTOGRAPH NO. 27
TETRA TECH

1. Minor cracking in the asphalt surface of the parking lot was observed at various locations, but this does not represent major damage requiring immediate repair. No cracks appeared to be wider than ¼ inch wide and none appeared to have penetrated the asphalt surface into the underlying fill; however, the cracking indicates that weathering is beginning to impact the asphalt. GWCC may want to consider filling in the cracks, resealing the new asphalt surfaces, and restriping them before weathering processes begin to create major damage on the asphalt parking lot.

Subject: A small crack in the asphalt leading to the stormwater drains on the eastern side of the parking lot. Stormwater flows in this low point of the parking lot, which has caused minor staining. The crack is estimated to be approximately 200 feet long, ¼ inch wide and ¼ inch deep. The existing crack was still present, but had not increased in size.

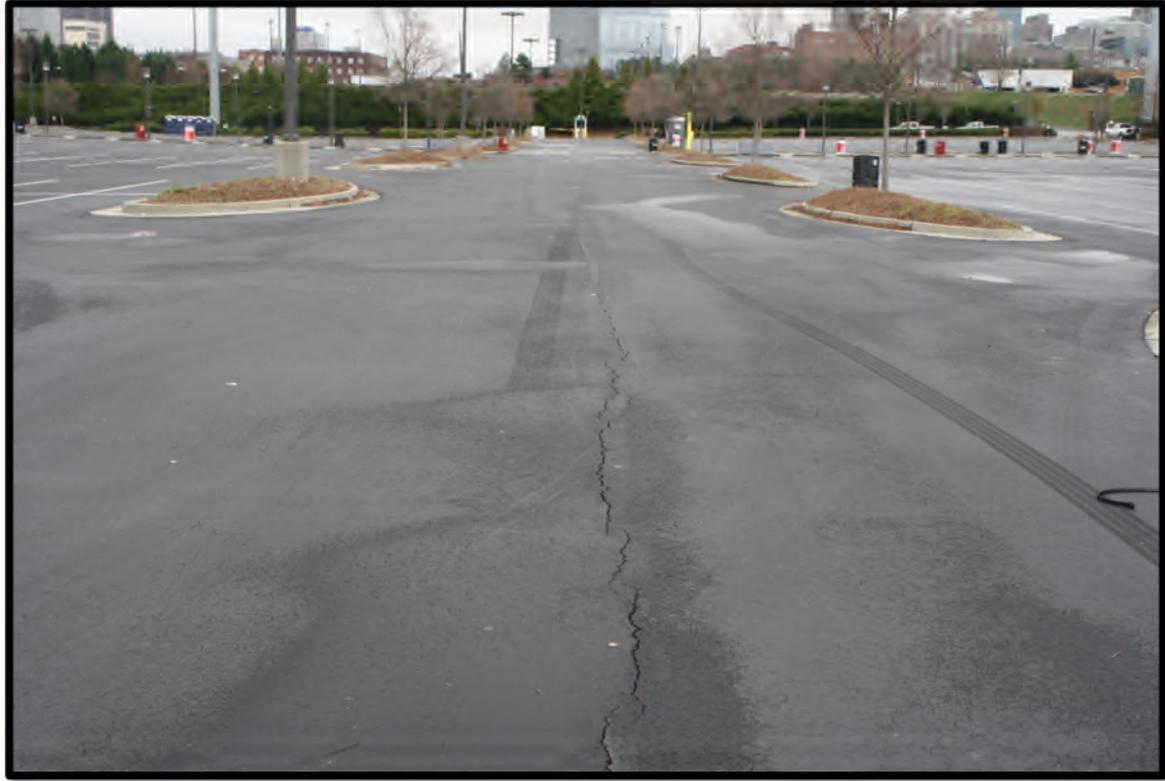
**OFFICIAL PHOTOGRAPH NO. 28
TETRA TECH**

Subject: Example of another crack which runs east to west on the main entrance/exit roadway. Like the previously observed crack, it is no larger than ¼ inch wide and ¼ inch deep. This crack traverses almost the entire length of the entrance/exit roadway. The existing crack was still present, but had not increased in size.

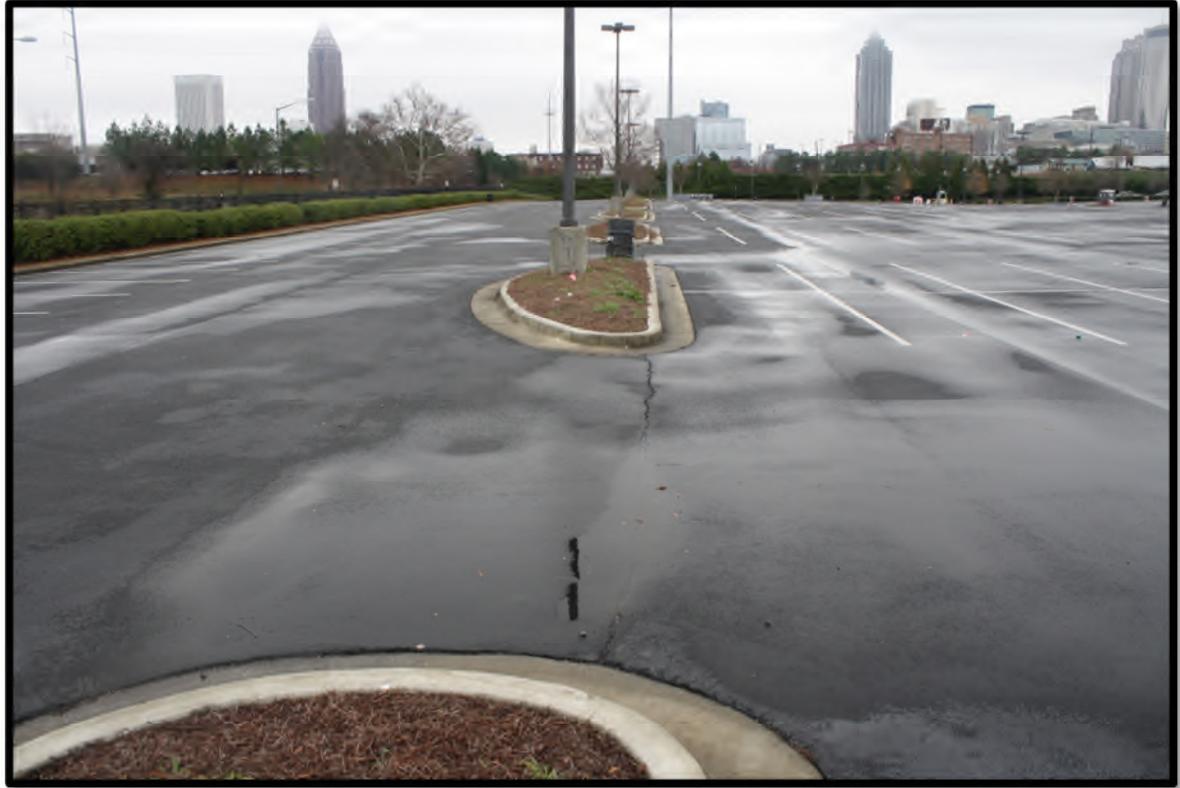
**OFFICIAL PHOTOGRAPH NO. 29
TETRA TECH**

Subject: Example of another crack which runs east to west on the entrance way of the parking lot row. Over half of the rows have cracks similar to this one. They occur where the asphalt seams are joined. Like the previously observed crack, it is no larger than ¼ inch wide and ¼ inch deep. The existing crack was still present, but had not increased in size.

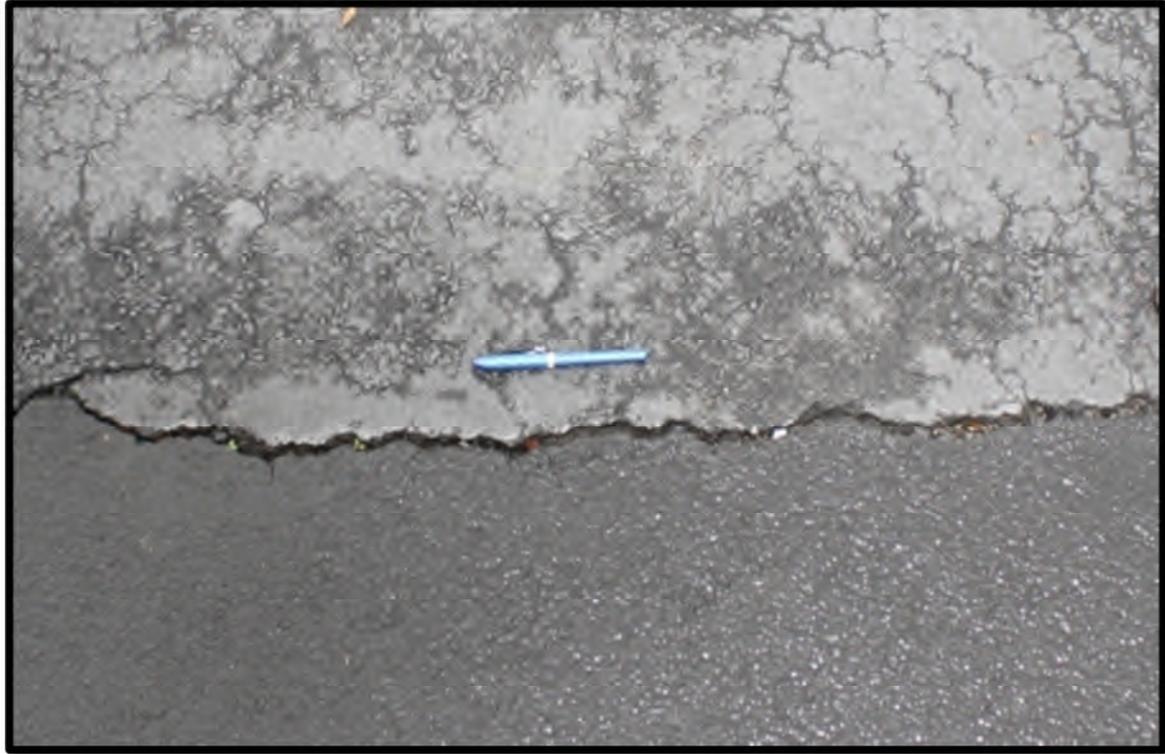
**OFFICIAL PHOTOGRAPH NO. 30
TETRA TECH**

Subject: Example of another crack, which runs north to south on the western most row of the north parking lot. A standard pen is used to show the approximate width of the crack. The width of this crack is typical of all cracks observed in the asphalt of the north parking lot. The existing crack was still present, but had not increased in size.

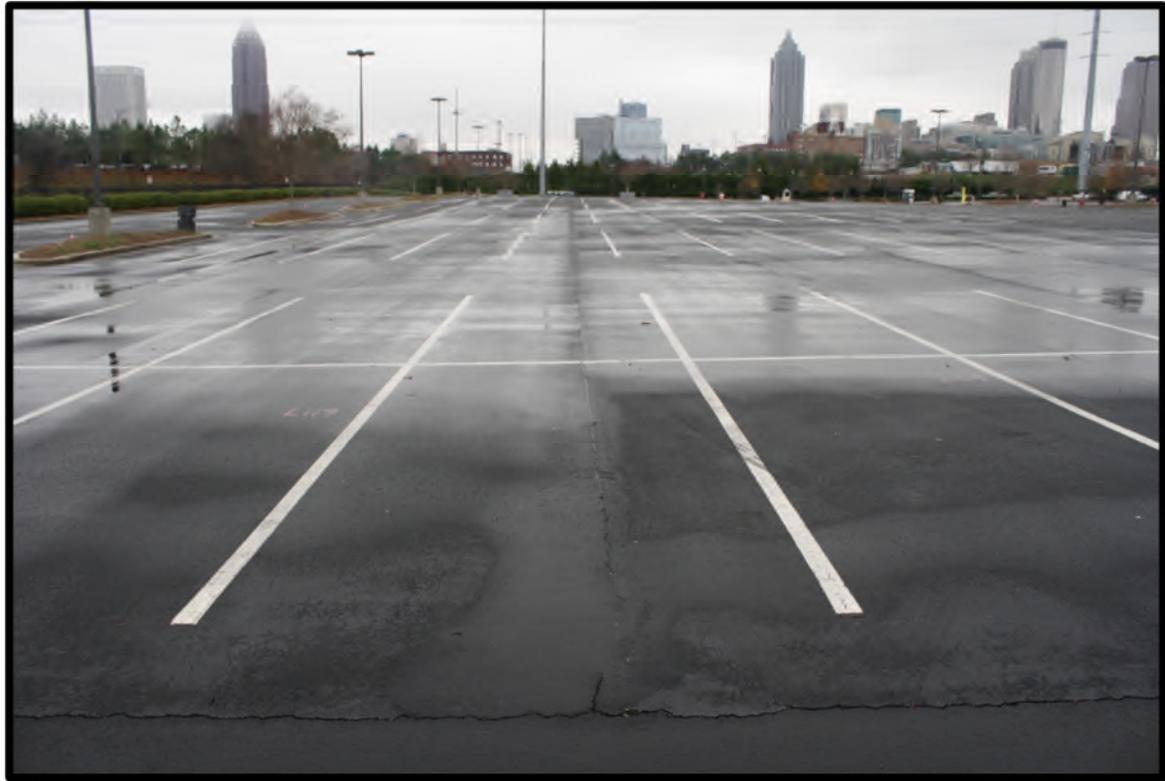
**OFFICIAL PHOTOGRAPH NO. 31
TETRA TECH**

Subject: Example of another crack which runs east to west. This crack is located on the northern portion of the parking lot and traverses the entire parking lot west of the north/south walkway. Once again, this crack occurs where the asphalt seams are joined. Like the previously observed cracks, it is no larger than $\frac{1}{4}$ inch wide and $\frac{1}{4}$ inch deep. The existing crack was still present, but had not increased in size.

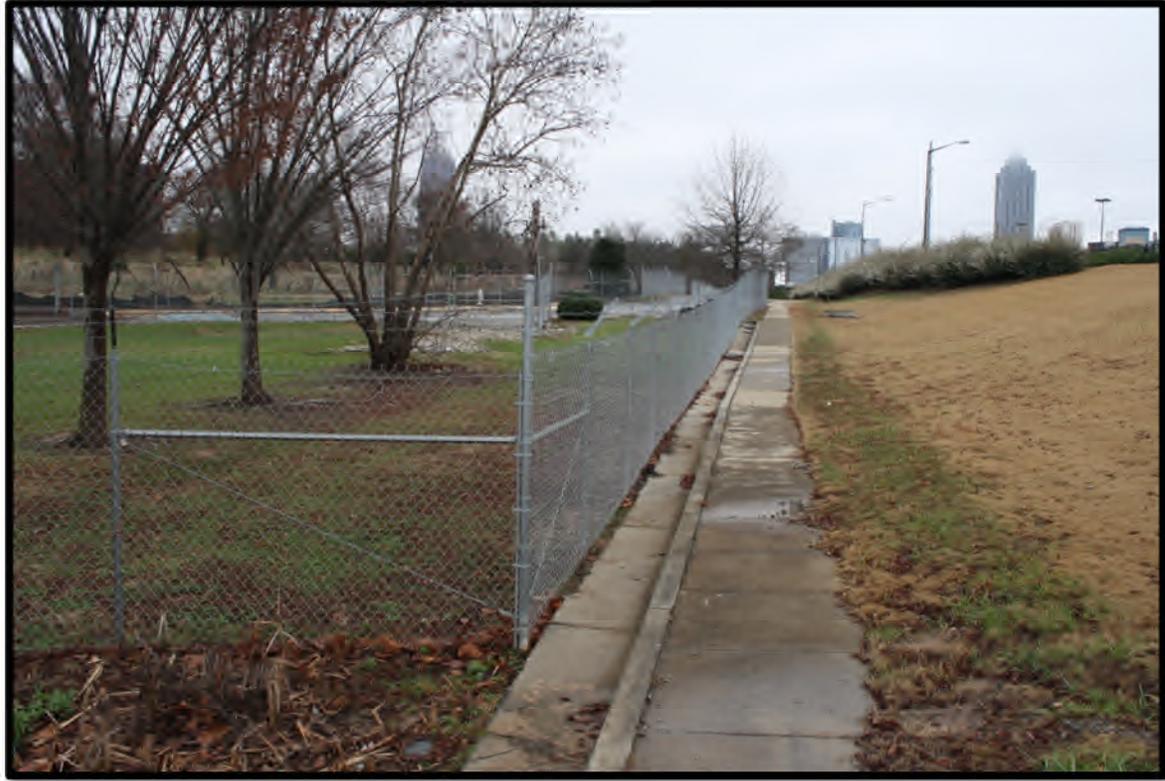
OFFICIAL PHOTOGRAPH NO. 32
TETRA TECH

Subject: Monitoring wells, MM-02, MWC-3B and MWC-3C are inside the fence line between the trees.

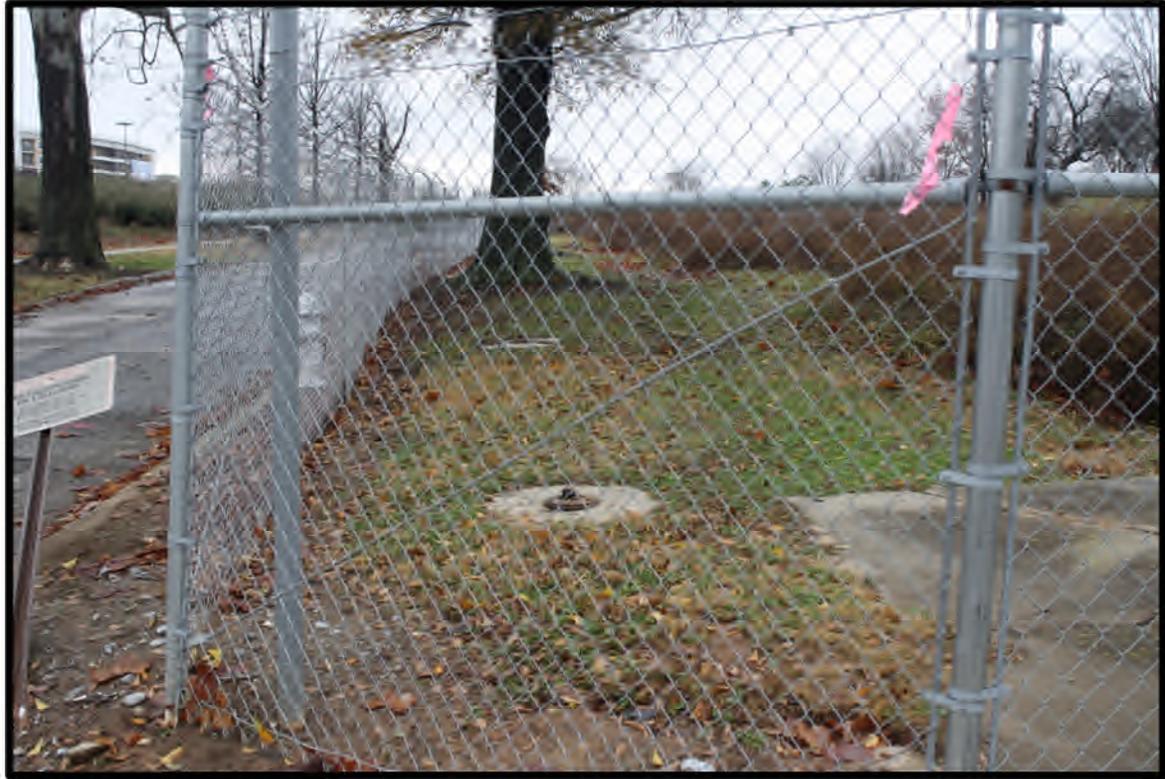
OFFICIAL PHOTOGRAPH NO. 33
TETRA TECH

Subject: Monitoring wells, MW-1A, MW-1B and MW-1C at the corner of John Street and Gray Street.

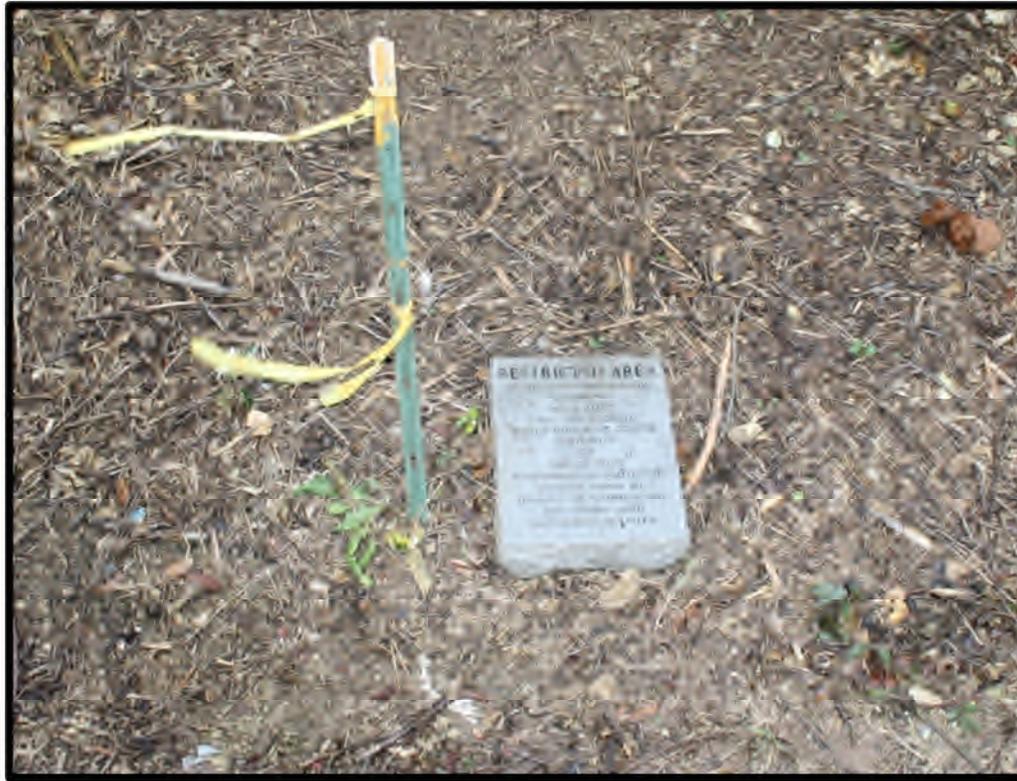
**OFFICIAL PHOTOGRAPH NO. 34
TETRA TECH**

Subject: Granite plaque on the northern perimeter of the property. This plaque was noted to be missing in previous inspections due to overgrown brush.

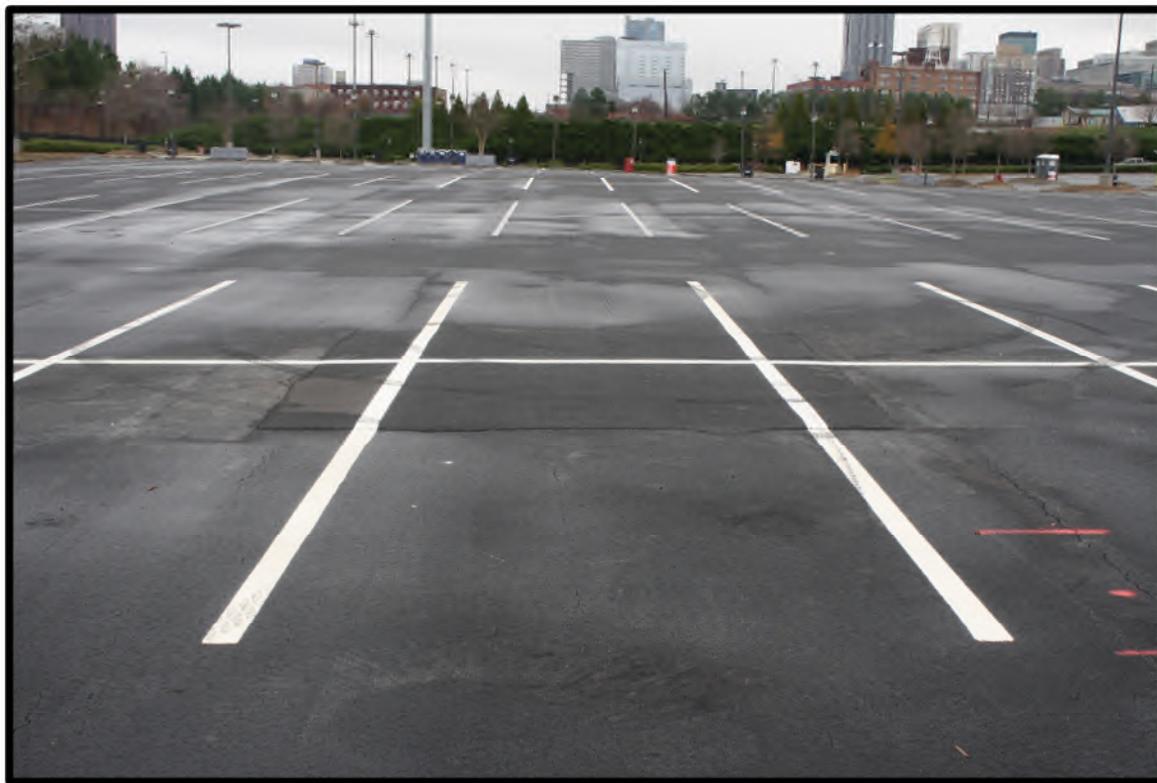
OFFICIAL PHOTOGRAPH NO. 35
TETRA TECH

Subject: Restored asphalt patch for direct push location DP-30, located in the northwest part of the parking lot.

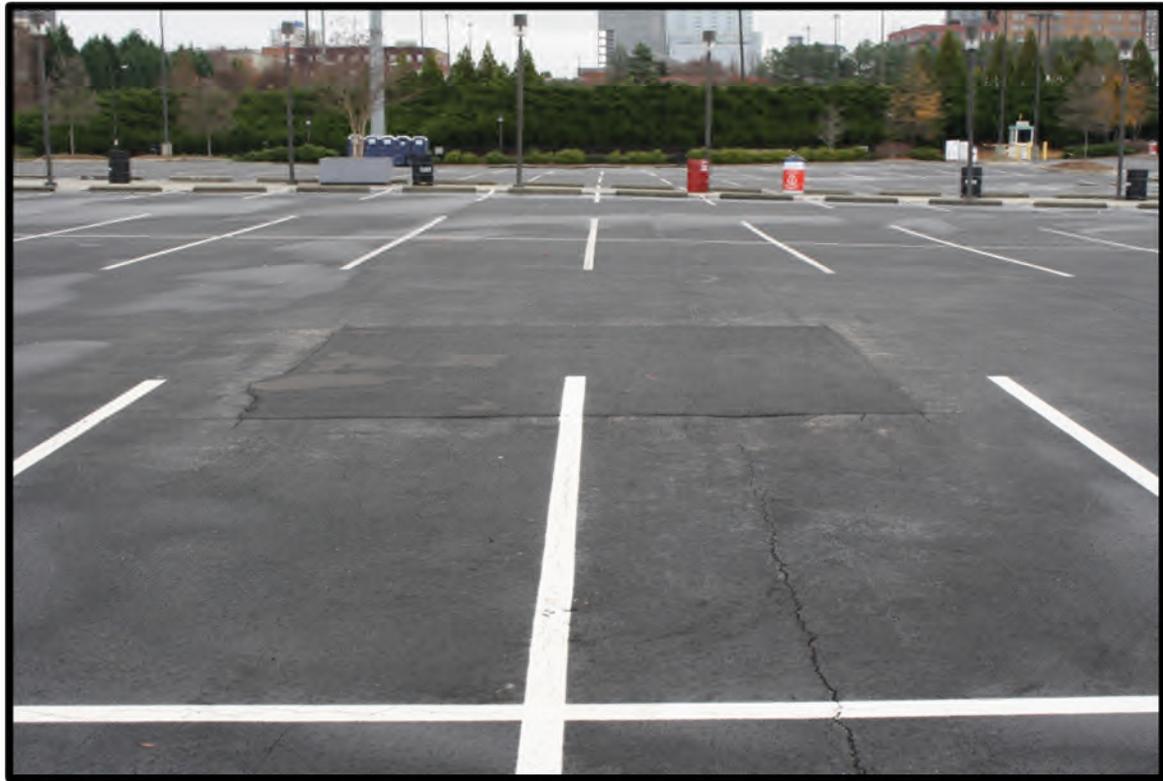
**OFFICIAL PHOTOGRAPH NO. 36
TETRA TECH**

Subject: Restored asphalt patch for direct push location DP-31, located in the north part of the parking lot.

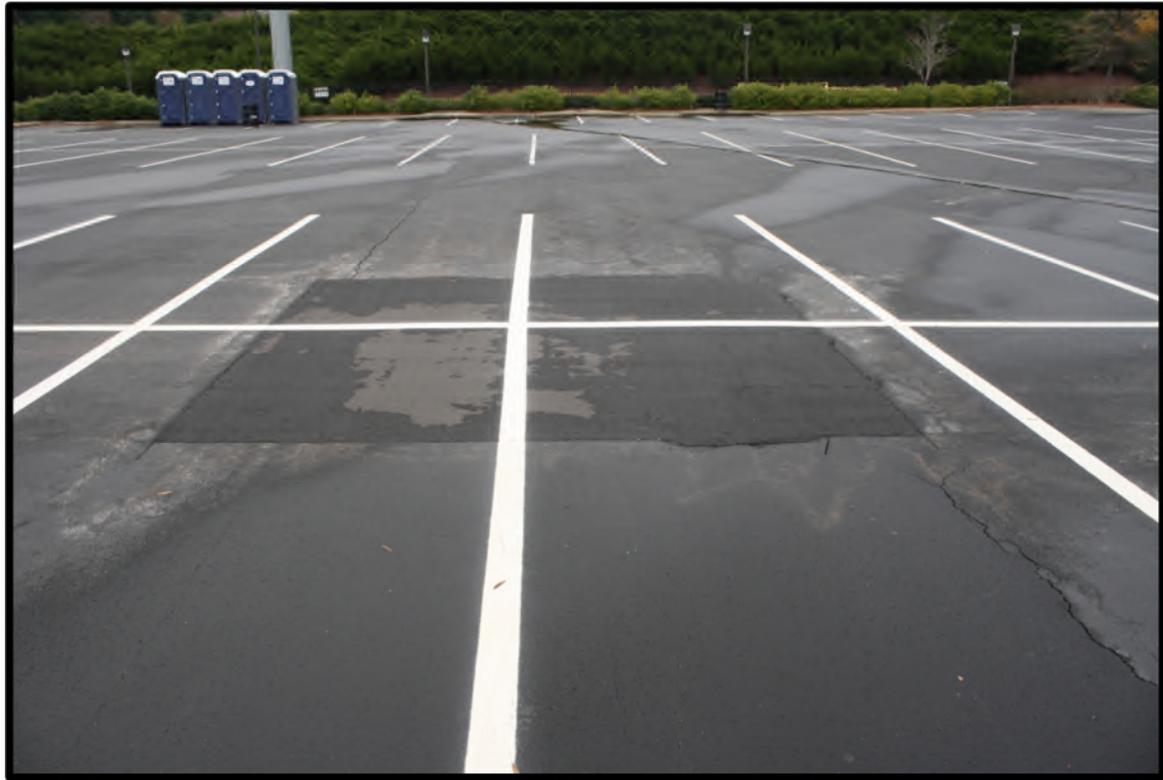
**OFFICIAL PHOTOGRAPH NO. 37
TETRA TECH**

Subject: Restored asphalt patch for direct push location DP-32, located in the northeast part of the parking lot.

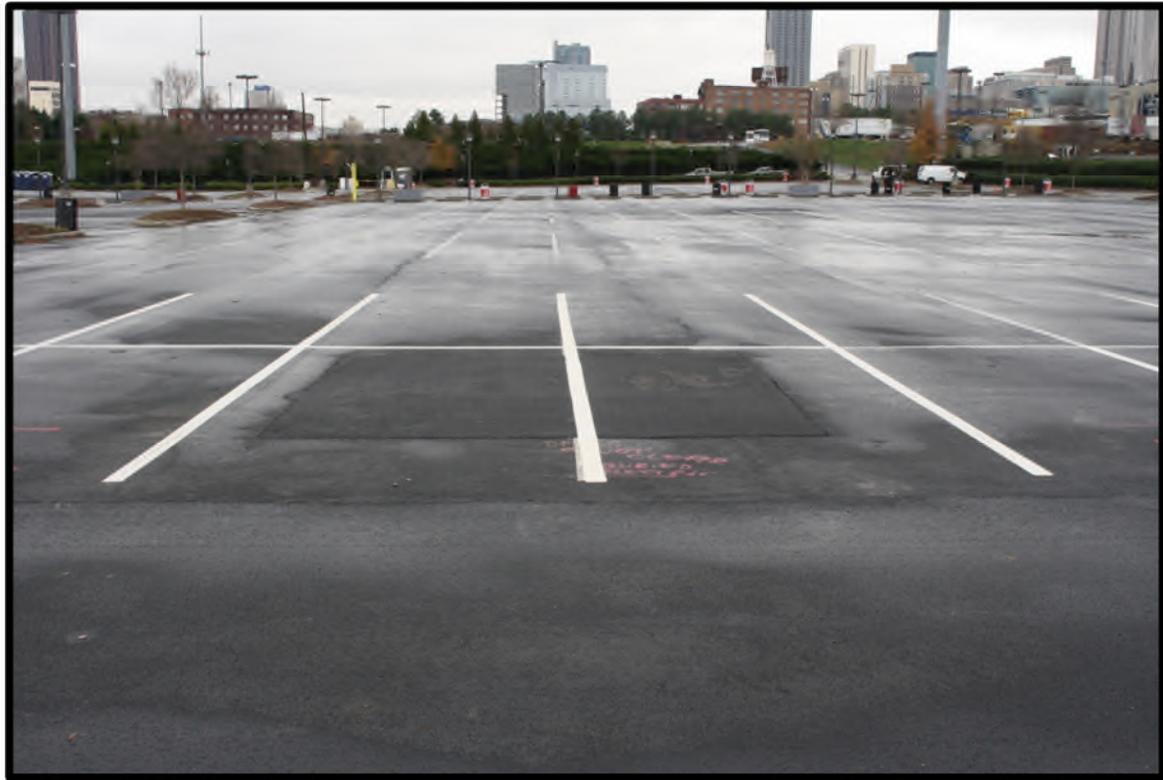
**OFFICIAL PHOTOGRAPH NO. 38
TETRA TECH**

Subject: Restored asphalt patch for direct push location DP-33, located in the southwest part of the parking lot.

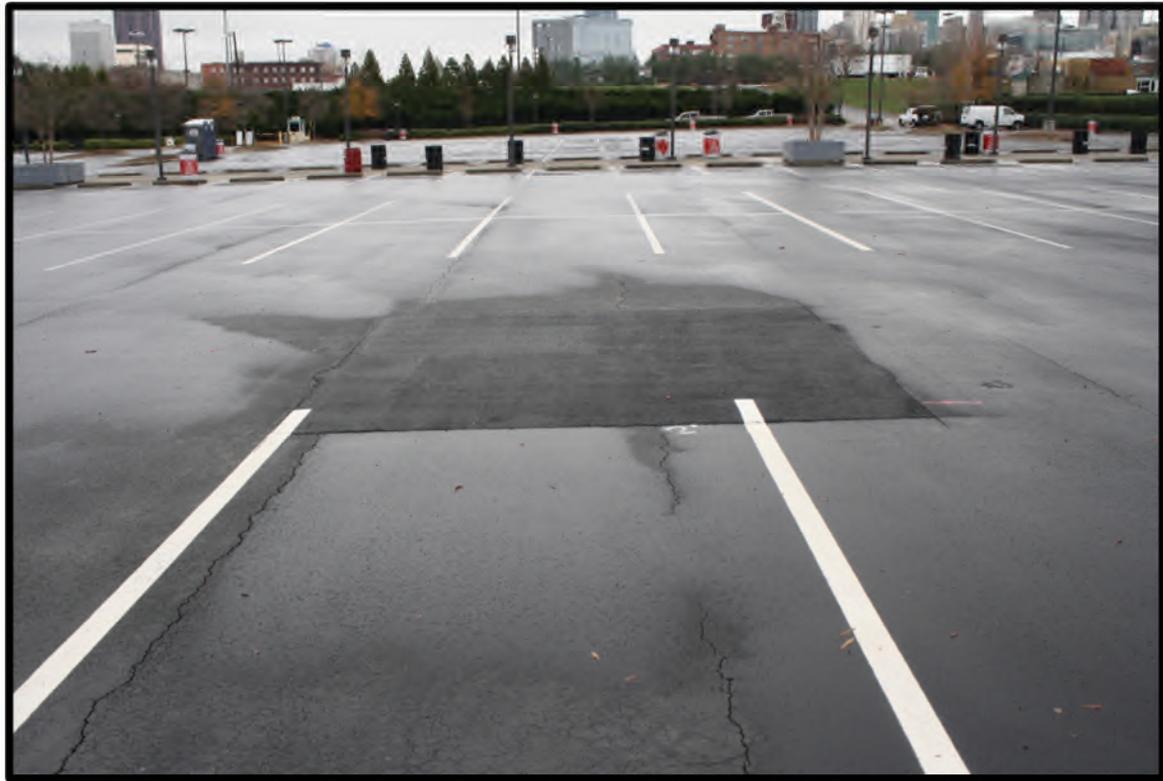
**OFFICIAL PHOTOGRAPH NO. 39
TETRA TECH**

Subject: Restored asphalt patch for direct push location DP-34, located in the south part of the parking lot.

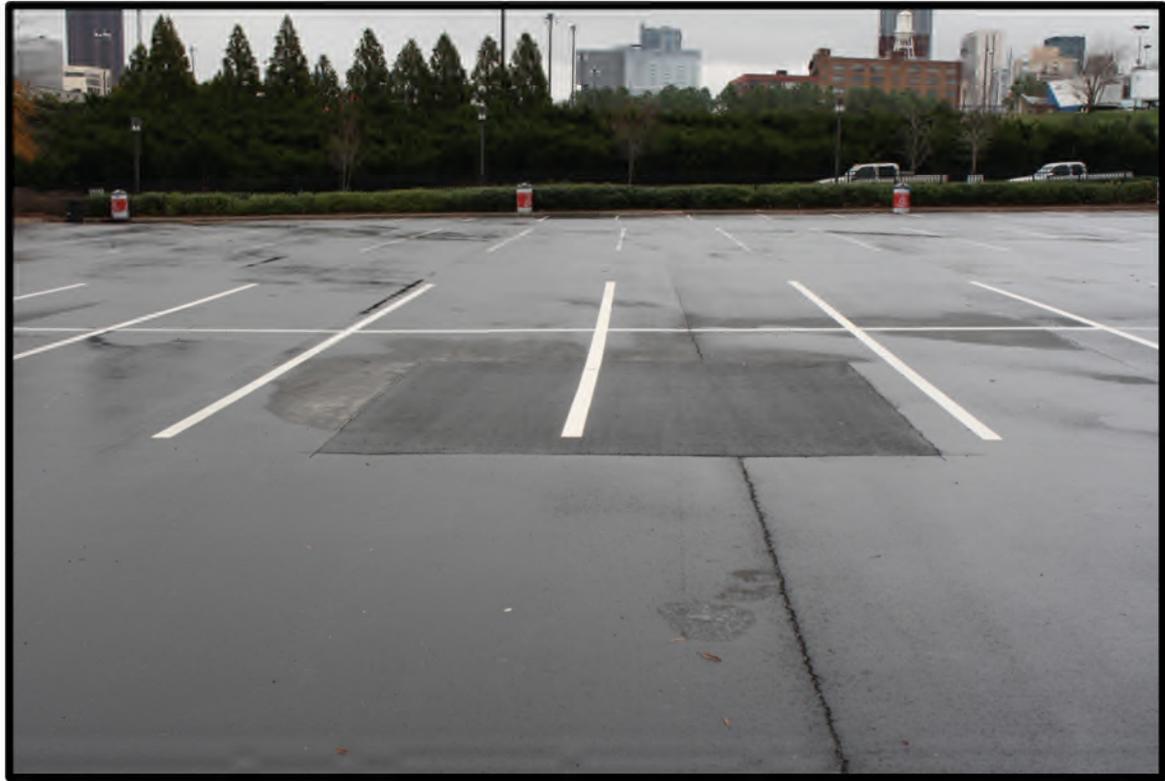
**OFFICIAL PHOTOGRAPH NO. 40
TETRA TECH**

Subject: Restored asphalt patch for direct push location DP-35, located in the southeast part of the parking lot.

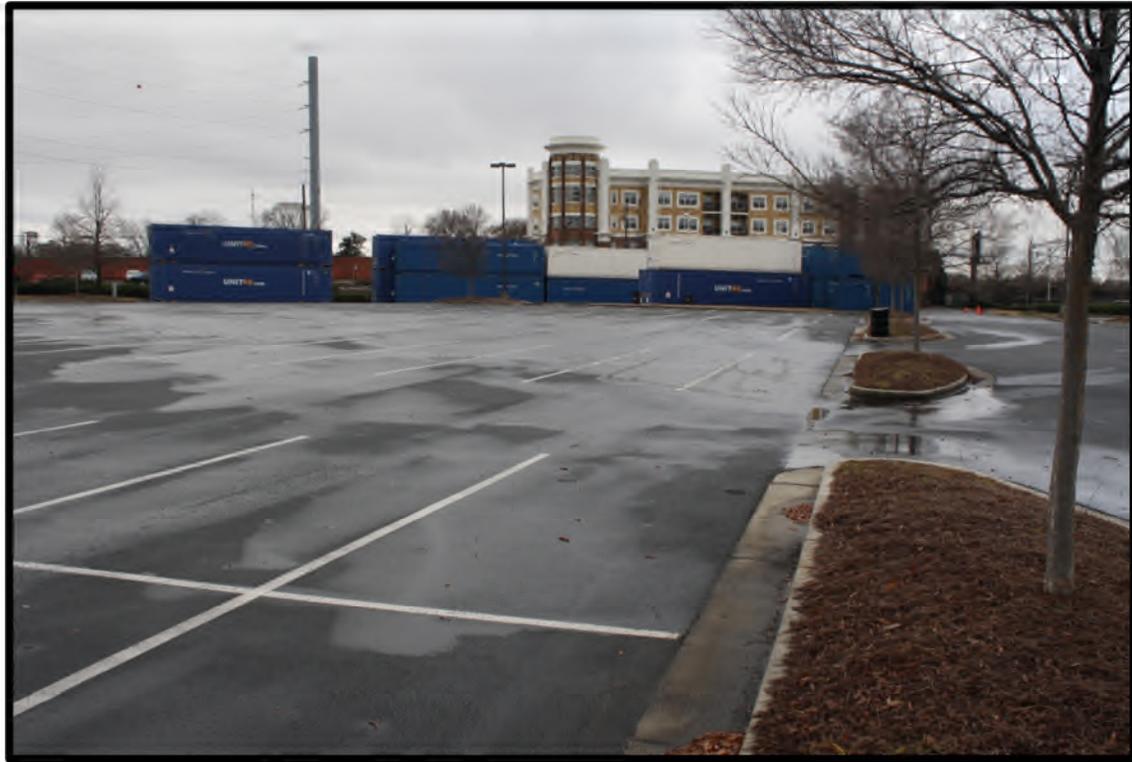
**OFFICIAL PHOTOGRAPH NO. 41
TETRA TECH**

During both the September and December 2013 inspections, Tetra Tech observed a number of sea-land shipping containers placed at the western end of the parking lot, adjacent to Northside Drive. The containers, shown in photograph 41 of the respective photographic logs, are located at the edge of the parking area, outside the limits of the slurry wall and no damage to the parking lot or landscaping structures was observed during our inspections. As shown in photograph 26A in each photographic log, the containers have been placed so that the storm drain present at that location is not blocked.

Subject: Cargo containers stored along the western side of the parking lot.
