Subject: **Response to Georgia Environmental Protection Division May 16, 2019 Comments on the VRP CSR Addendum and 2018 Annual Monitoring and Inspection Report Thermo King Corporation - Louisville, Jefferson County, Georgia HSI Site No. 10702 Tax Parcel 0090-024 Wood Project 6122-09-0322**

**REVISED OPERATION AND MAINTENANCE PLAN AND INSPECTION SCHEDULES FOR
ENGINEERING CONTROLS
7/18/2019**

**RESPONSE TO GEORGIA ENVIRONMENTAL PROTECTION DIVISION COMMENTS
DATED MAY 16, 2019 FOR THE THERMO KING CORPORATION SITE –
LOUISVILLE, JEFFERSON COUNTY, GEORGIA**

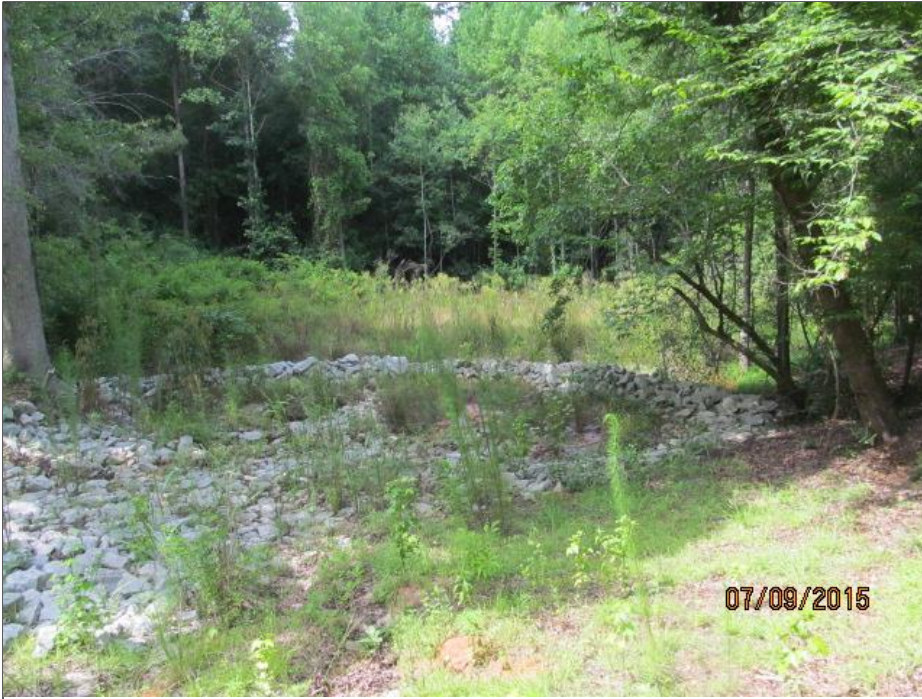
Client: Ingersoll Rand
Location: ThermoKing, Louisville, GA
Project: Riprap Blanket Inspection
Date: 1/9/14
Photo #: 078
Photographer:
Description: Riprap blanket and check dam at MB#2

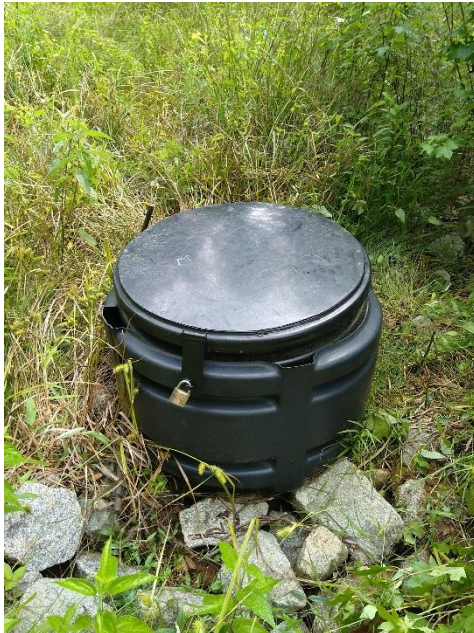
Manson Branch # 2 Seep

Seep access secured with padlocks looking N

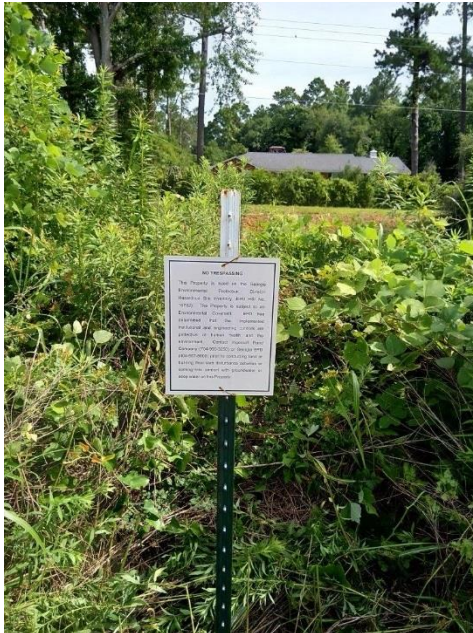
Marker 2

Closeup of marker sign looking towards N

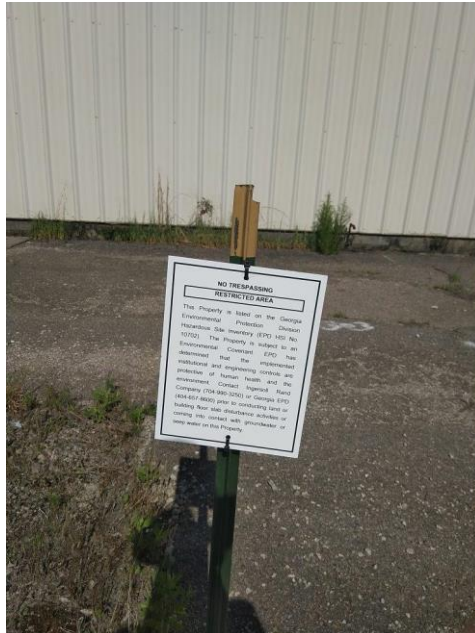
Marker 19

Closeup of area marker looking towards W
